The Influence  
of Tailings Dam  
Failures on  
Canadian  
Practice with  
an emphasis on  
Mount Polley  
and Fundao

- Canadian Geotechnical Society
- Toronto Branch
- March 23, 2022

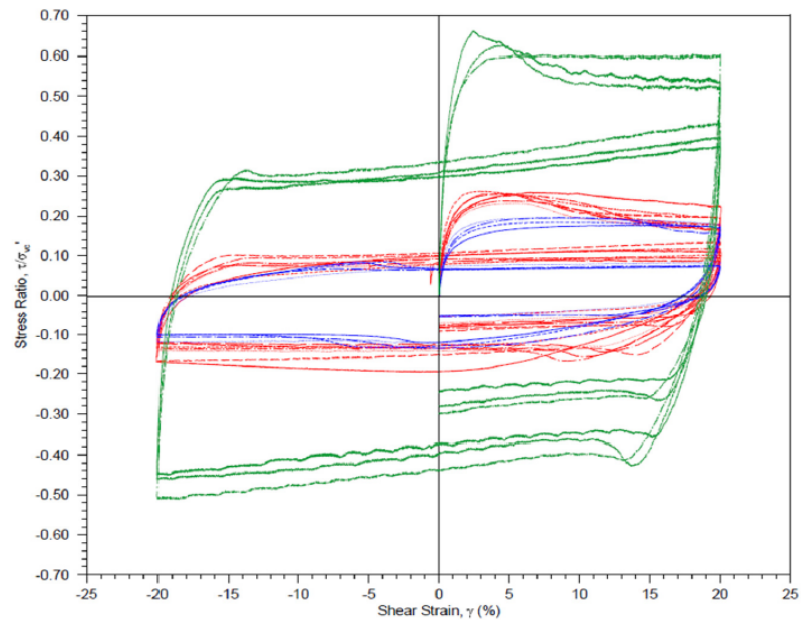
a) UGLU - MONOTONIC DIRECT SIMPLE SHEAR TESTING

- Failure induced in lightly over-consolidated to normally consolidated clay in the foundation
- Strain-weakening, but not brittle

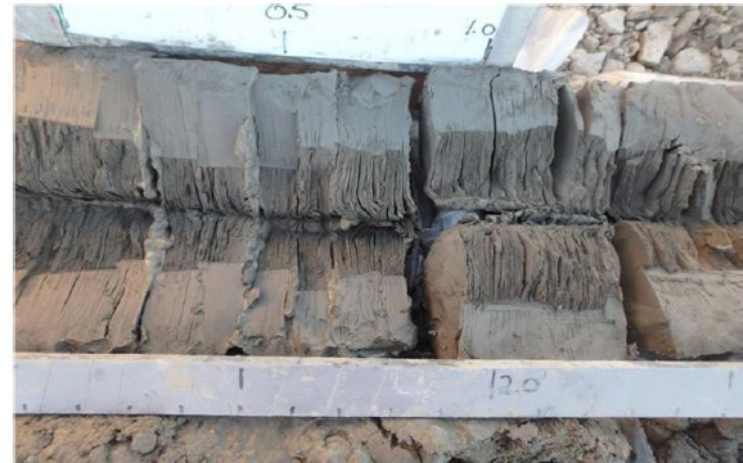
a) UGLU - FREE FIELD DOWNSTREAM OF FAILED EMBANKMENT

SH14-10 (Middle/Top UGLU Layer) Approximate El. 921.1 m to 919.5 ,m  
Sub-horizontal varved bedding. Water content = 35.7%; Liquid limit = 60%; Plastic index = 20%; Clay fraction = 58%

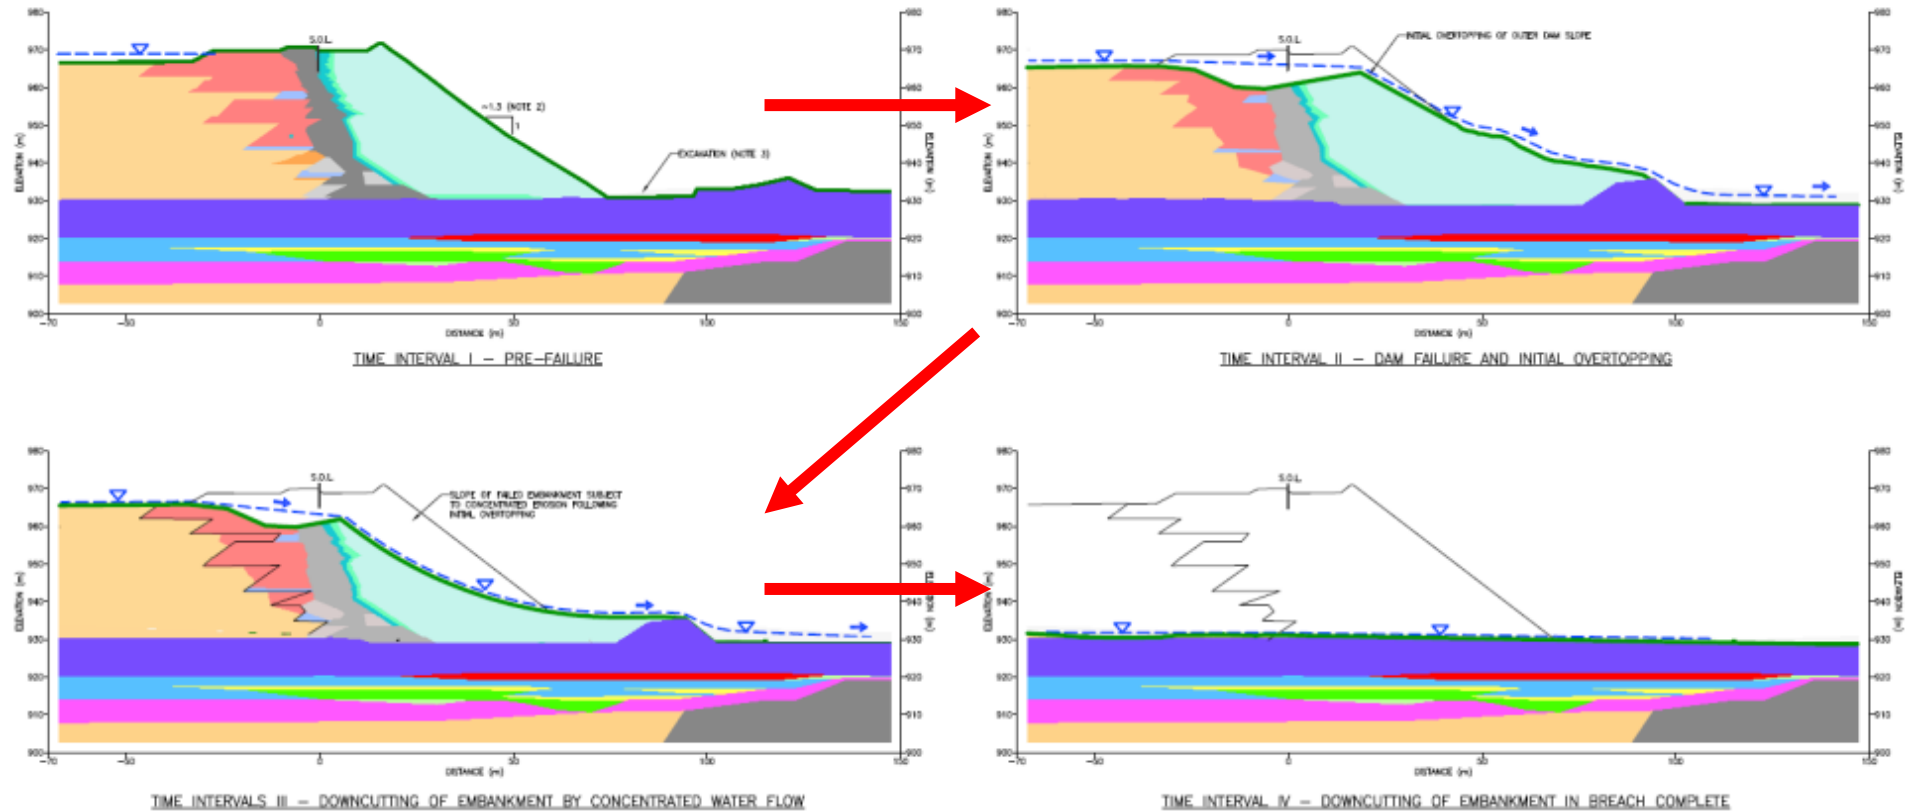
# Mount Polley, BC – Failure Illustration

Erosion followed the failure as the water overtopped the slumped crest of the embankment.

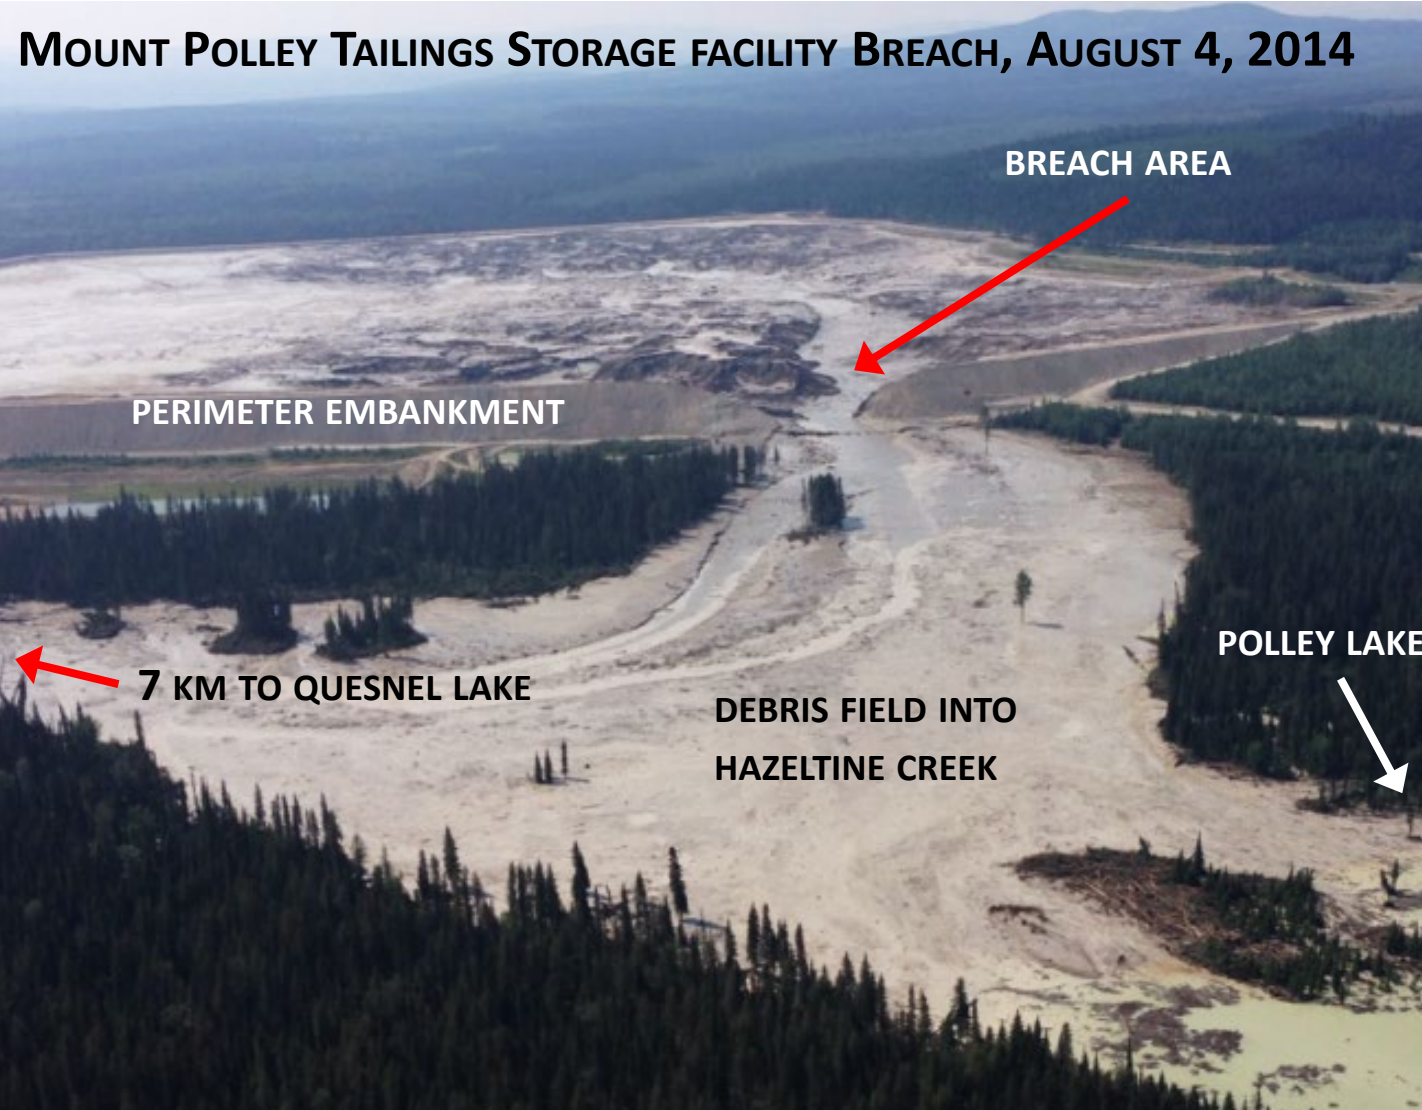
# Mount Polley, BC – Failure Consequence

- Project team were unaware that the UGLU was present in this location under the perimeter dam. Two test holes drilled in 2011 were on either side of this narrow unit (about 100 m wide)
- Downstream slope was unusually steep at 1.3H:1V
- There was a shallow excavation at the toe of the Perimeter embankment which was not backfilled at the time of the failure
- Undrained failure caused by loss of undrained strength in transition from overconsolidated (OCR about 4 to 5) to normally consolidated response in the UGLU due to embankment loading
- Absence of any monitoring data to provide early warning

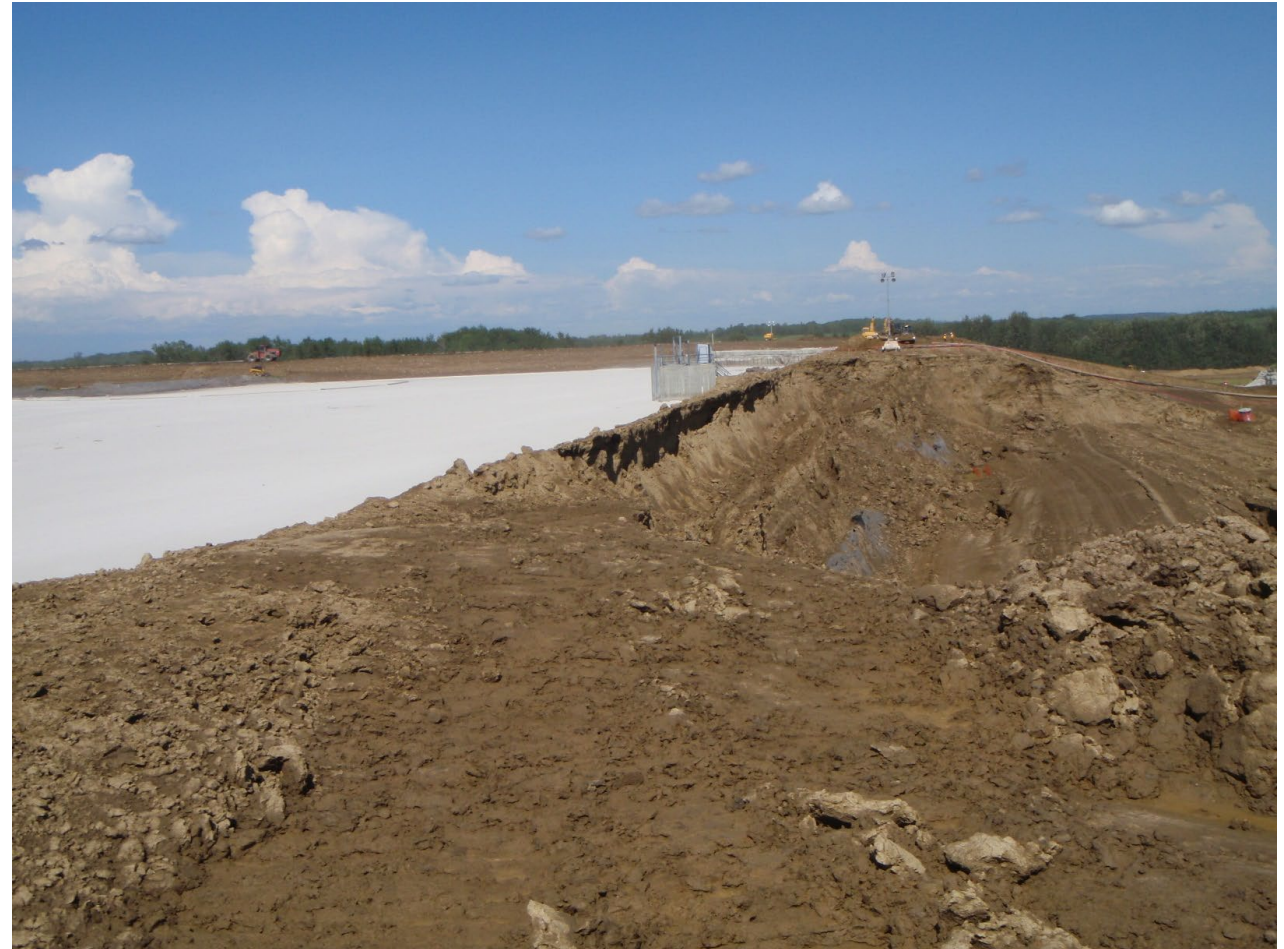
- As example downstream slope failure to the right occurred in 2008 in an embankment on the prairies on a weak clay foundation
- Forensic investigation used effective stress analyses exclusively. No consideration of the undrained failure mode
- Now, undrained static stability analyses are considered on every project in Canada using a basic Shansep approach if the foundation soils are cohesive

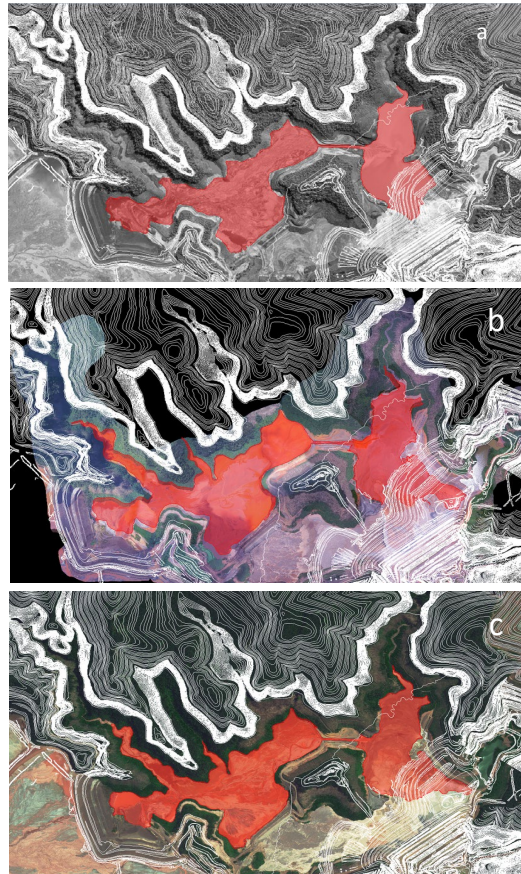
# Fundao Dam Failure – Slimes Encroachment

Slimes diverted to Dike 1 when principal gallery was being repaired

- (a) September 20, 2011;
- (b) January 21, 2012;
- (c) March 3, 2012

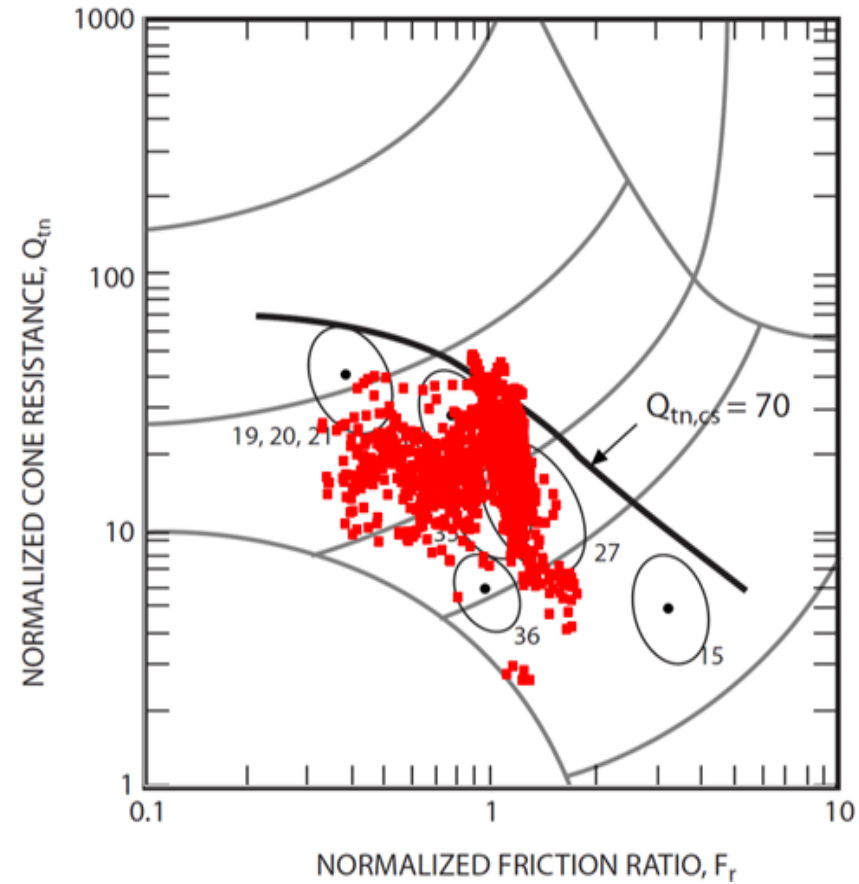
# Compilation of CPT Results on Robertson Chart

All tailings were liquefiable

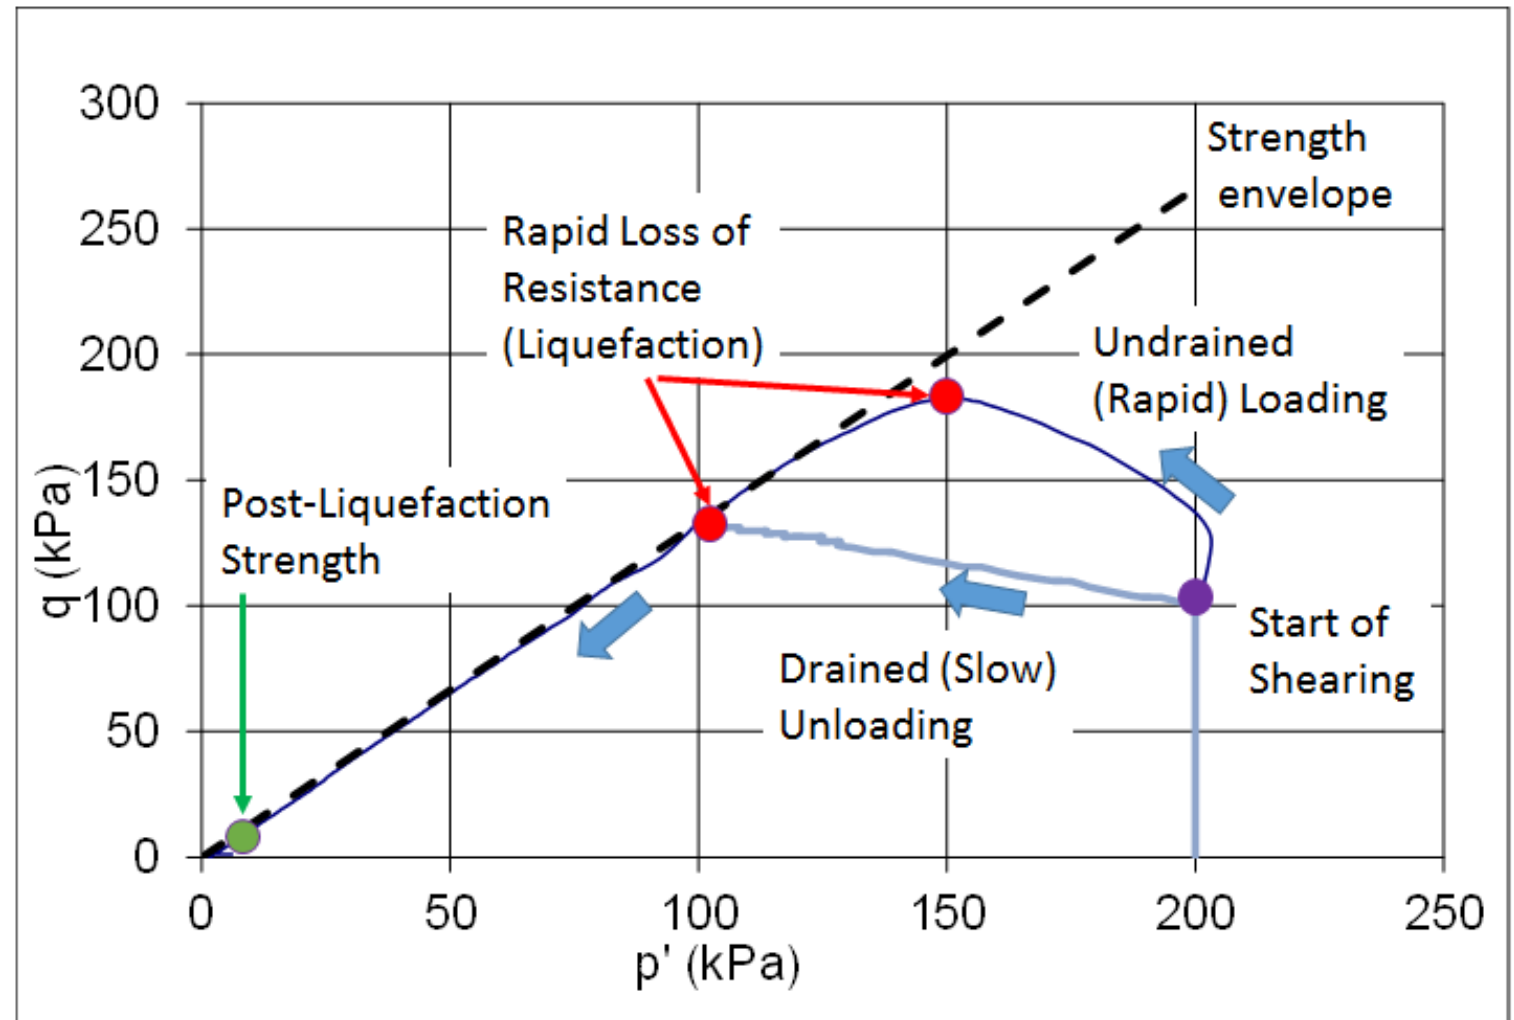
# Drained Path to Failure

The winning hypotheses – extrusion collapse

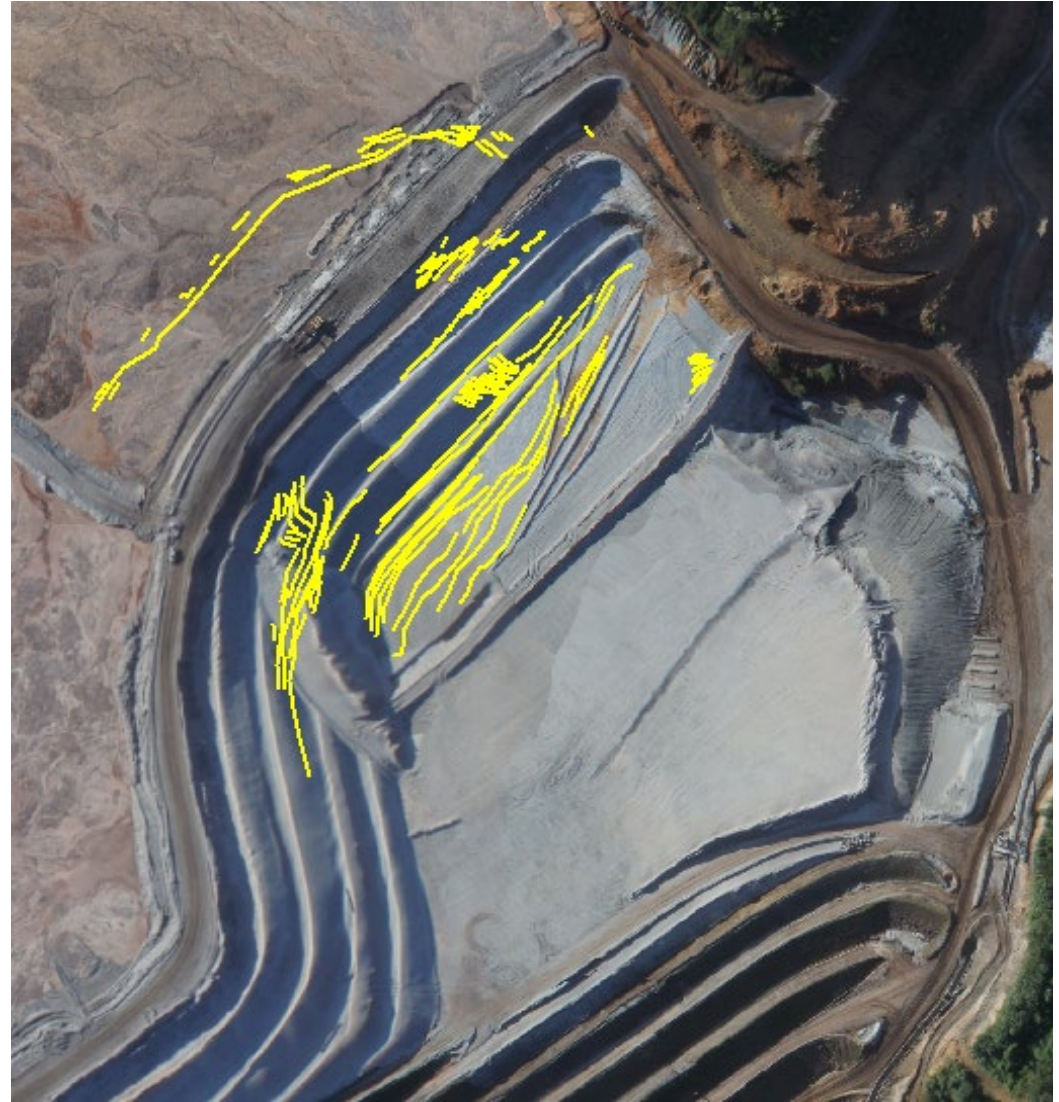
# Static Liquefaction Failure Mode Progression

- Must understand how failure modes can develop but drained static liquefaction stress path is difficult to impossible to monitor
- However, the dam essentially issued a warning in August 2014 that something was up
- This warning sign was not appreciated at the time.
- This warning was really only evident in hindsight.
