The Influence  
of Tailings Dam  
Failures on  
Canadian  
Practice with  
an emphasis on  
Mount Polley  
and Fundao

- Canadian Geotechnical Society
- Toronto Branch
- March 23, 2022

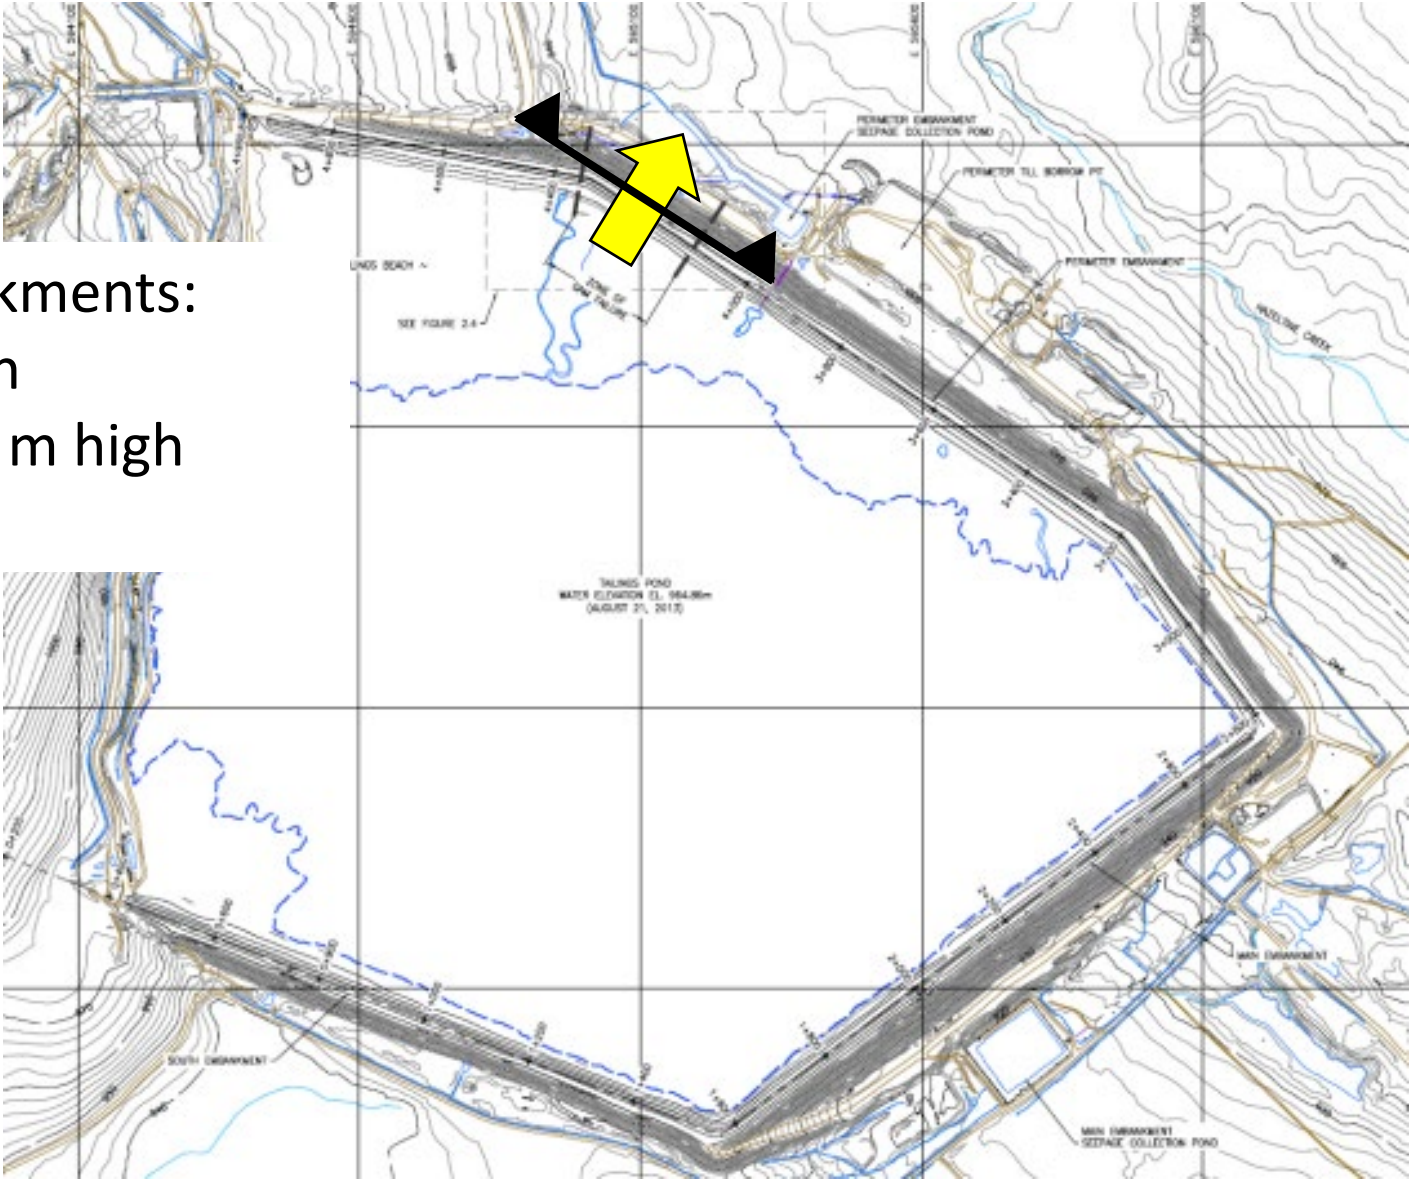
# Mount Polley, BC – Plan

- Three embankments:
- 4 km length
  - 40 m to 50 m high

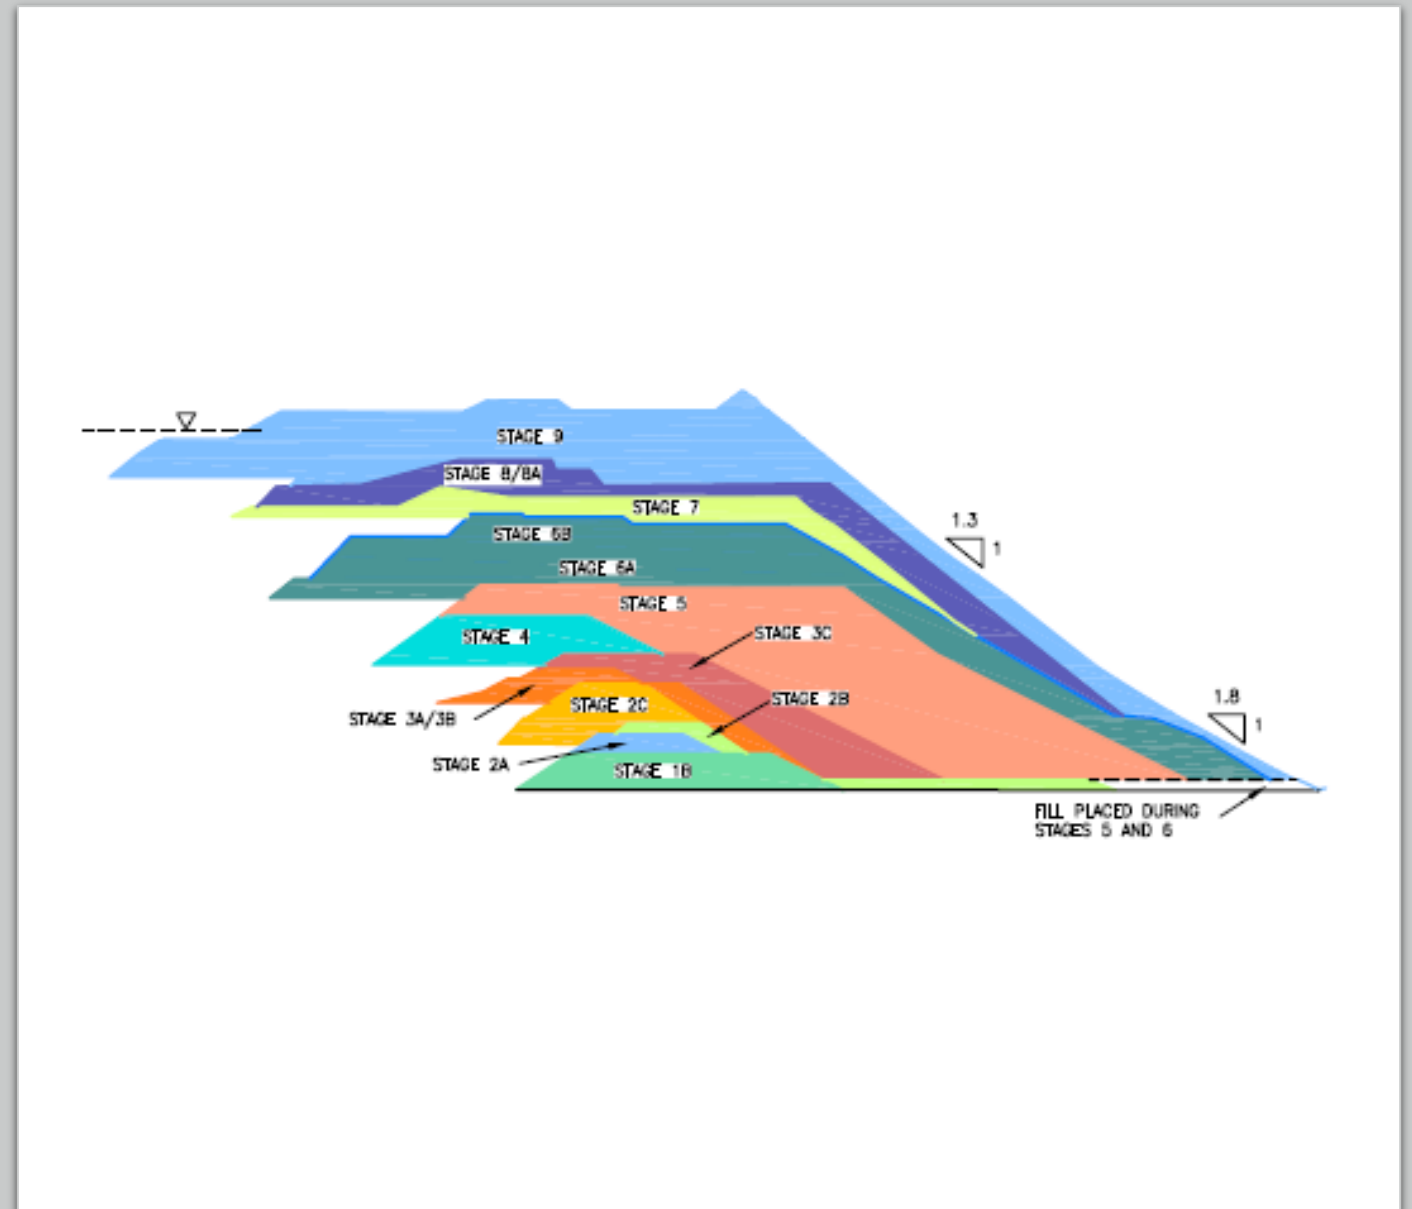
# Mount Polley, BC – Section & Construction Sequence

- Perimeter Embankment as-constructed condition:
- Constructed in 9 stages (raises)
- Modified centerline dam with low permeability core zone, downstream rockfill with filters

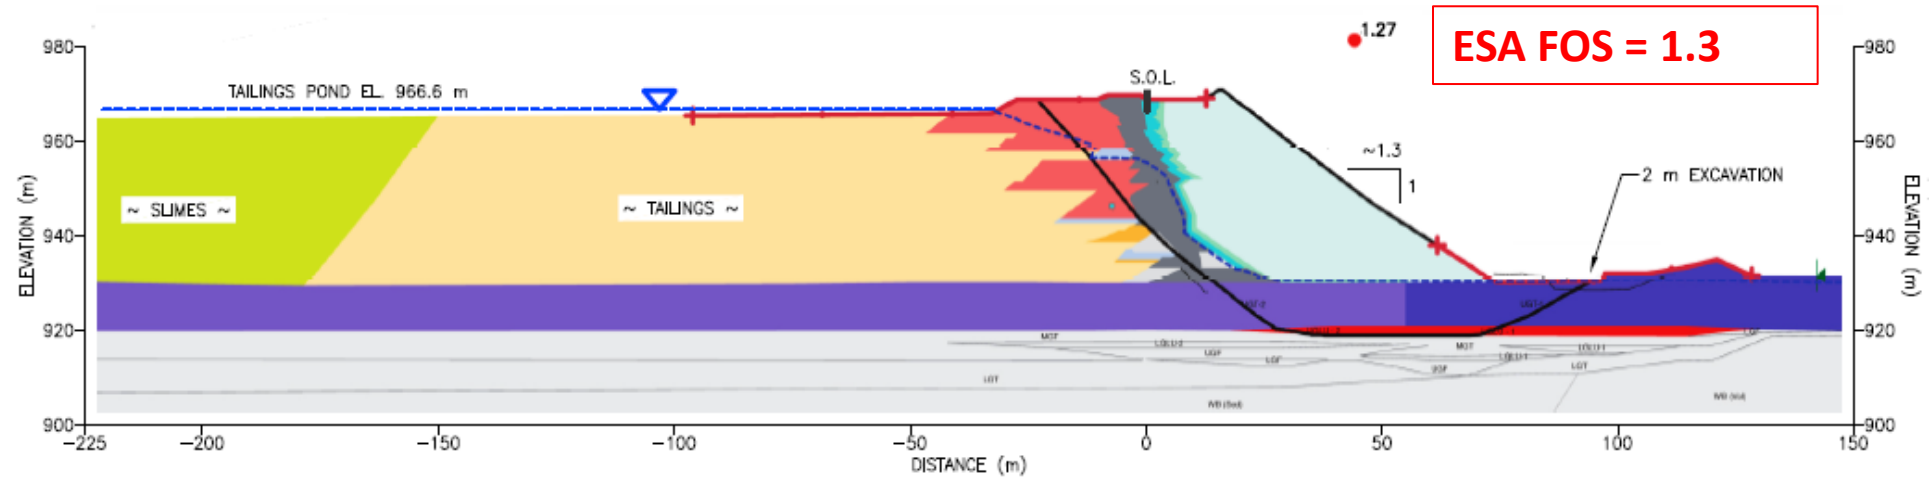
a) STAGE 1 – PEAK DRAINED STRENGTH IN UGLU

- Failure induced in lightly over-consolidated to normally consolidated clay in the foundation
- Strain-weakening, but not brittle

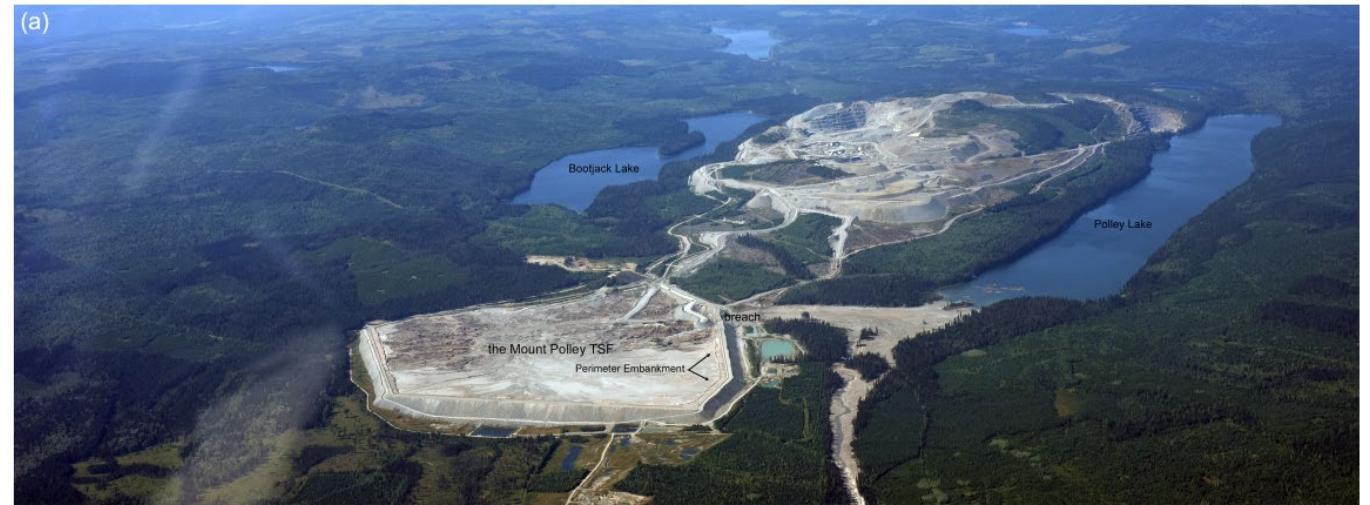
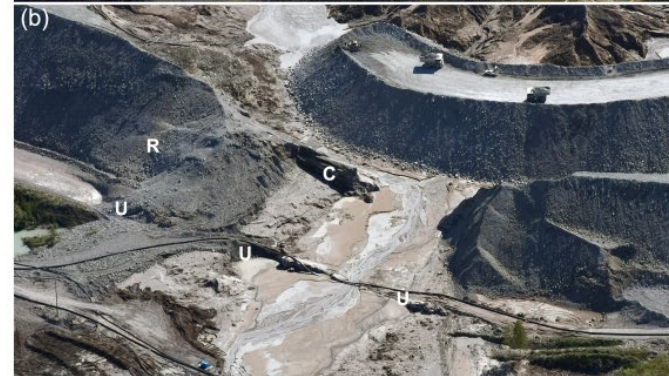
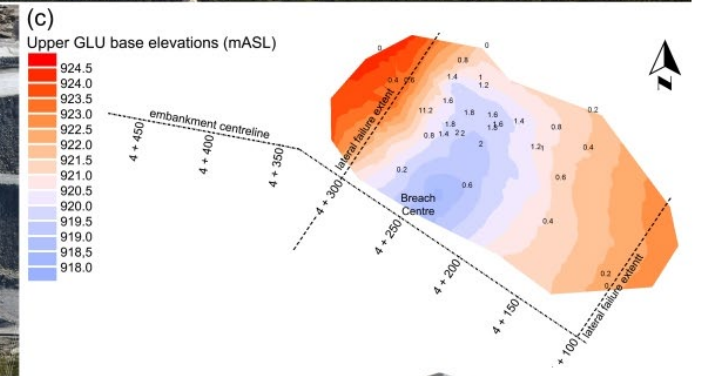
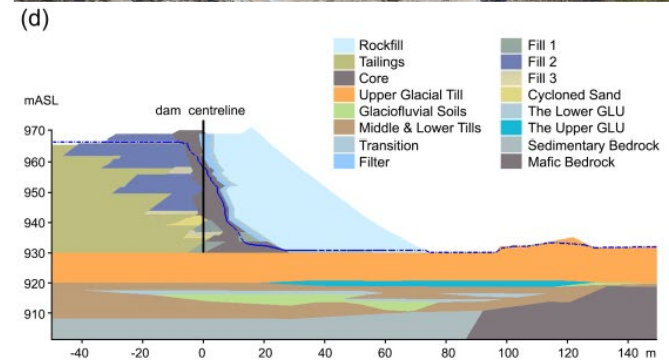
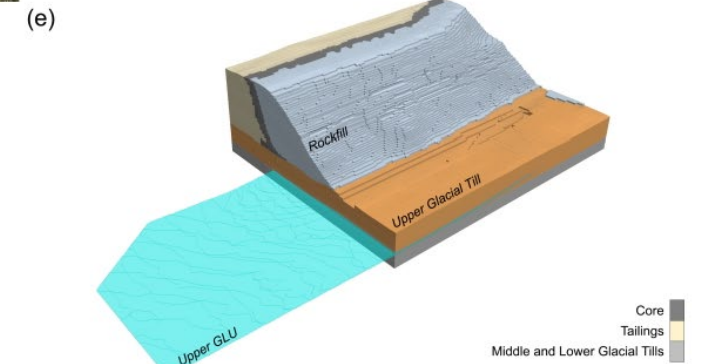
## Mechanism of Failure of the Mount Polley Tailings Storage Facility

- “Failure caused by a confluence of conditions:
  - a reduction of shear resistance in a small portion of the Upper GLU to post-peak values,
  - the development of local failures in the UGT above the strain-weakening zone and an associated reduction in the levels of mobilized shear resistance;
  - and the incomplete mobilization of shear strength in the rockfill until the late stages of collapse.
- The localization of strains in a shear band with a thickness  $\leq 12$ -13cm was requisite for the initiation of this failure, and the incomplete mobilization of shear strengths in the shell zone explains why the nominally considerable three-dimensional stability effects present in this slope did not act to stabilize it. “

So, shear band formation in the UGLU was necessary to explain the failure in a 3D analysis  
The more a failure is studied, the more is learned.

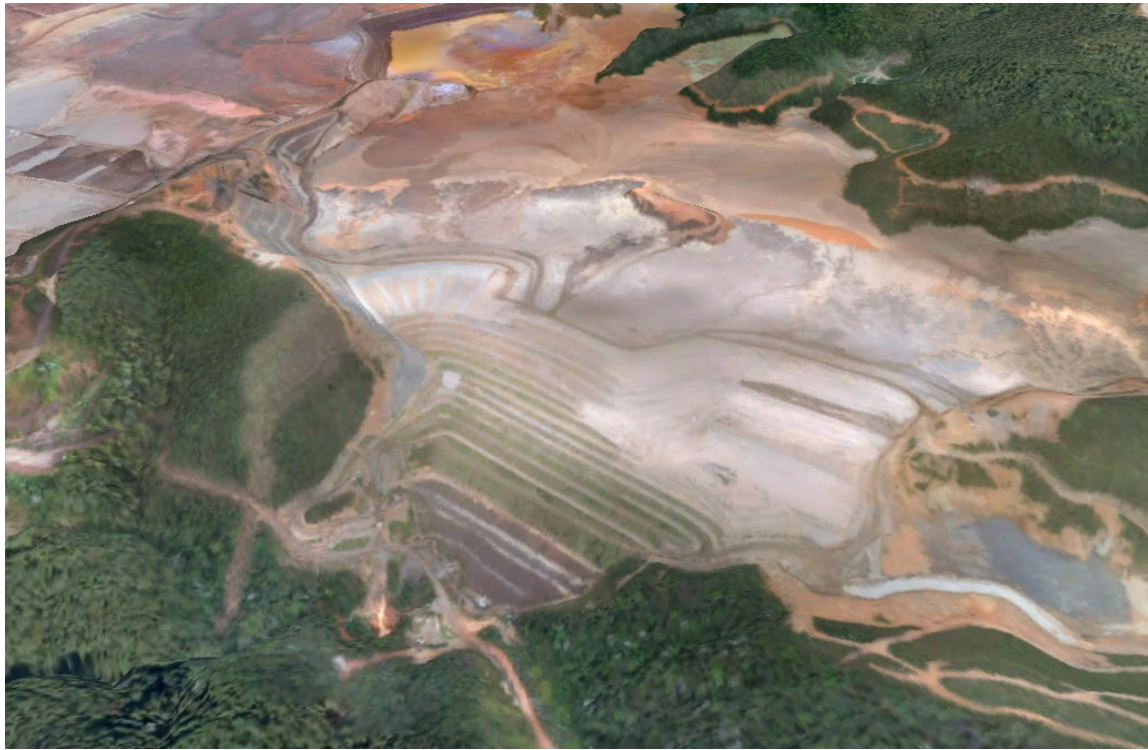
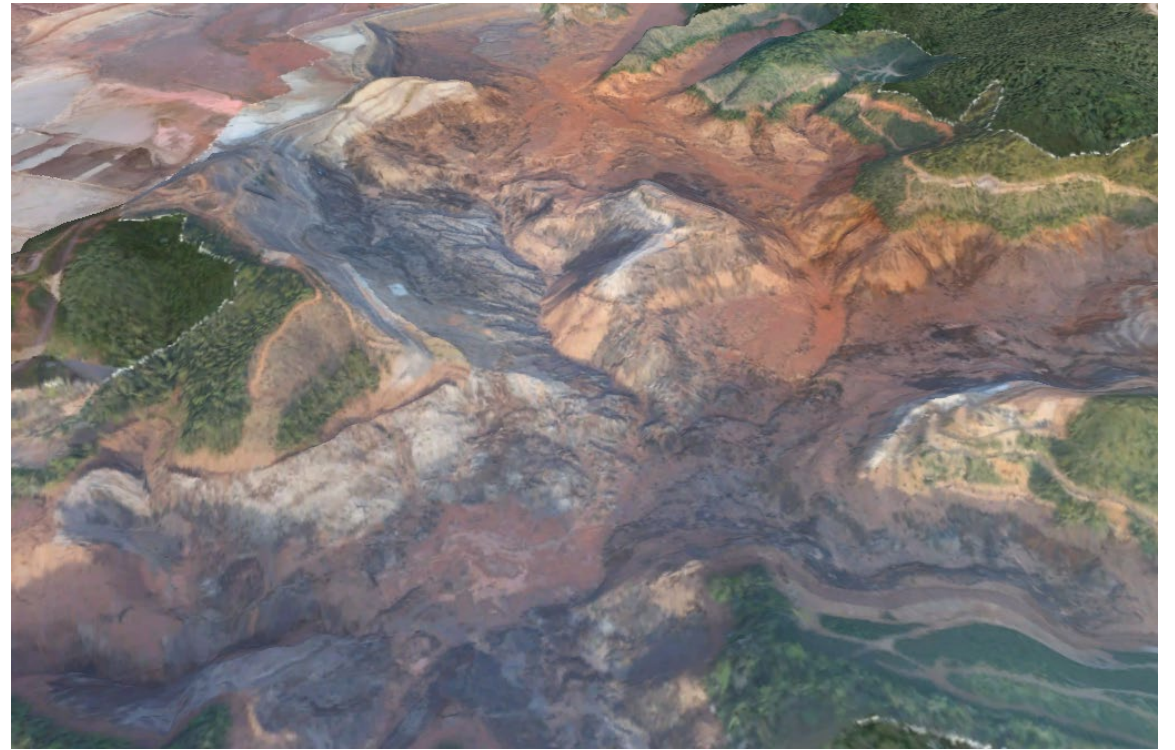
# Before and After

- Dam failed by static liquefaction on Nov. 5, 2015
- Dam was just one of several in the immediate vicinity to store tailings from open pit iron ore mining using the same design
- Crest at El. 900 m, toe at 795 m, so 105 m high
- Failure during raise to El. 920 m
- Planned to raise to El. 940 m
- Released 32Mm<sup>3</sup> of tailings to the environment

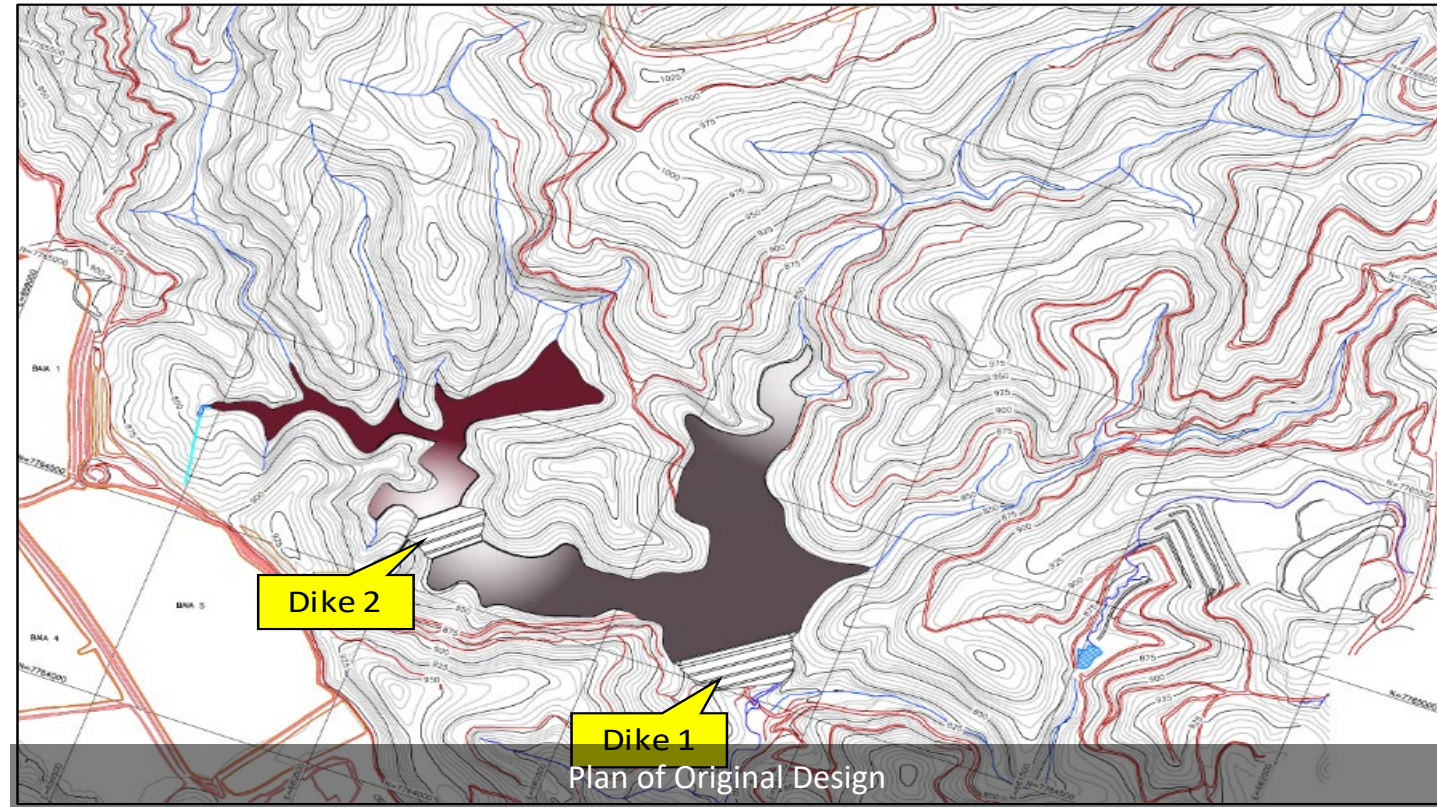
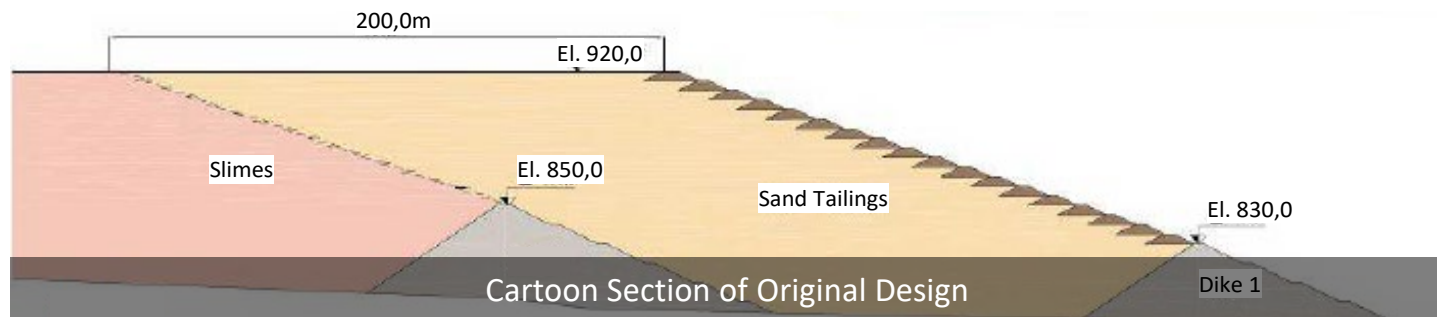
Original  
Design  
Concept –  
completely  
drained sand  
tailings

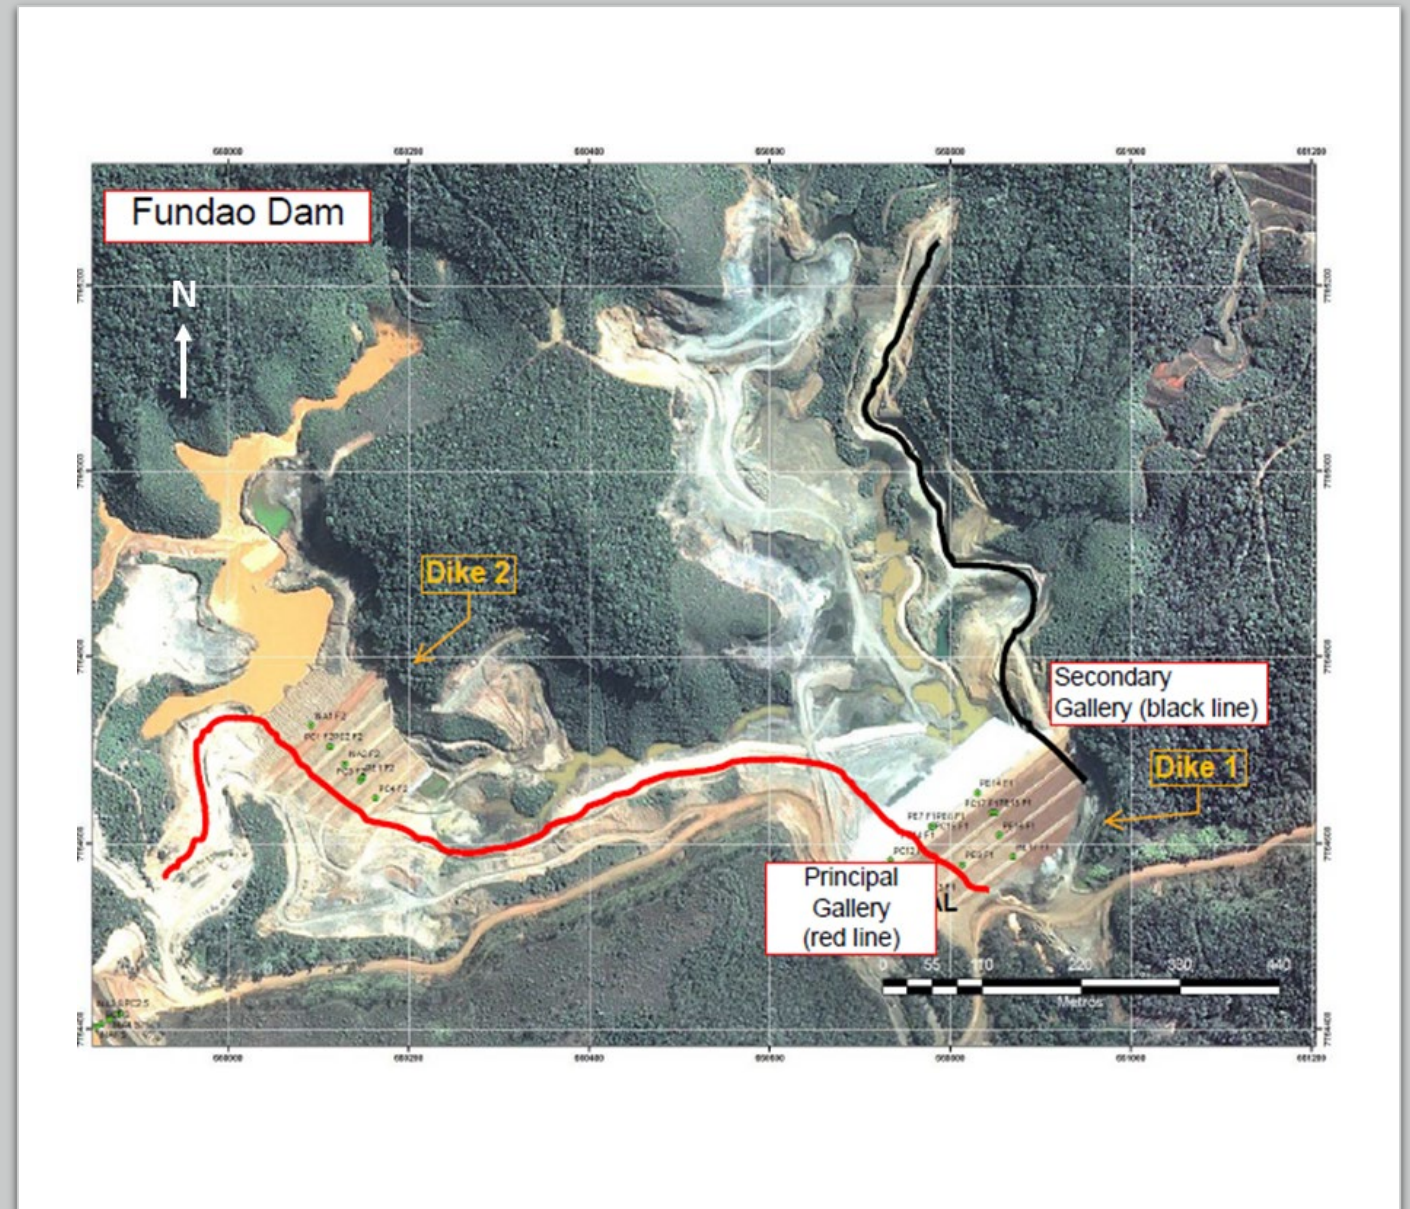
# Decant Conduits and Foundation Drainage

- Sand section was to be completely drained with valley finger drains discharging through Dike 1.
- Galleries were installed on the foundation soils to drain ponds to downstream dam.
- Both finger drains and galleries eventually failed.

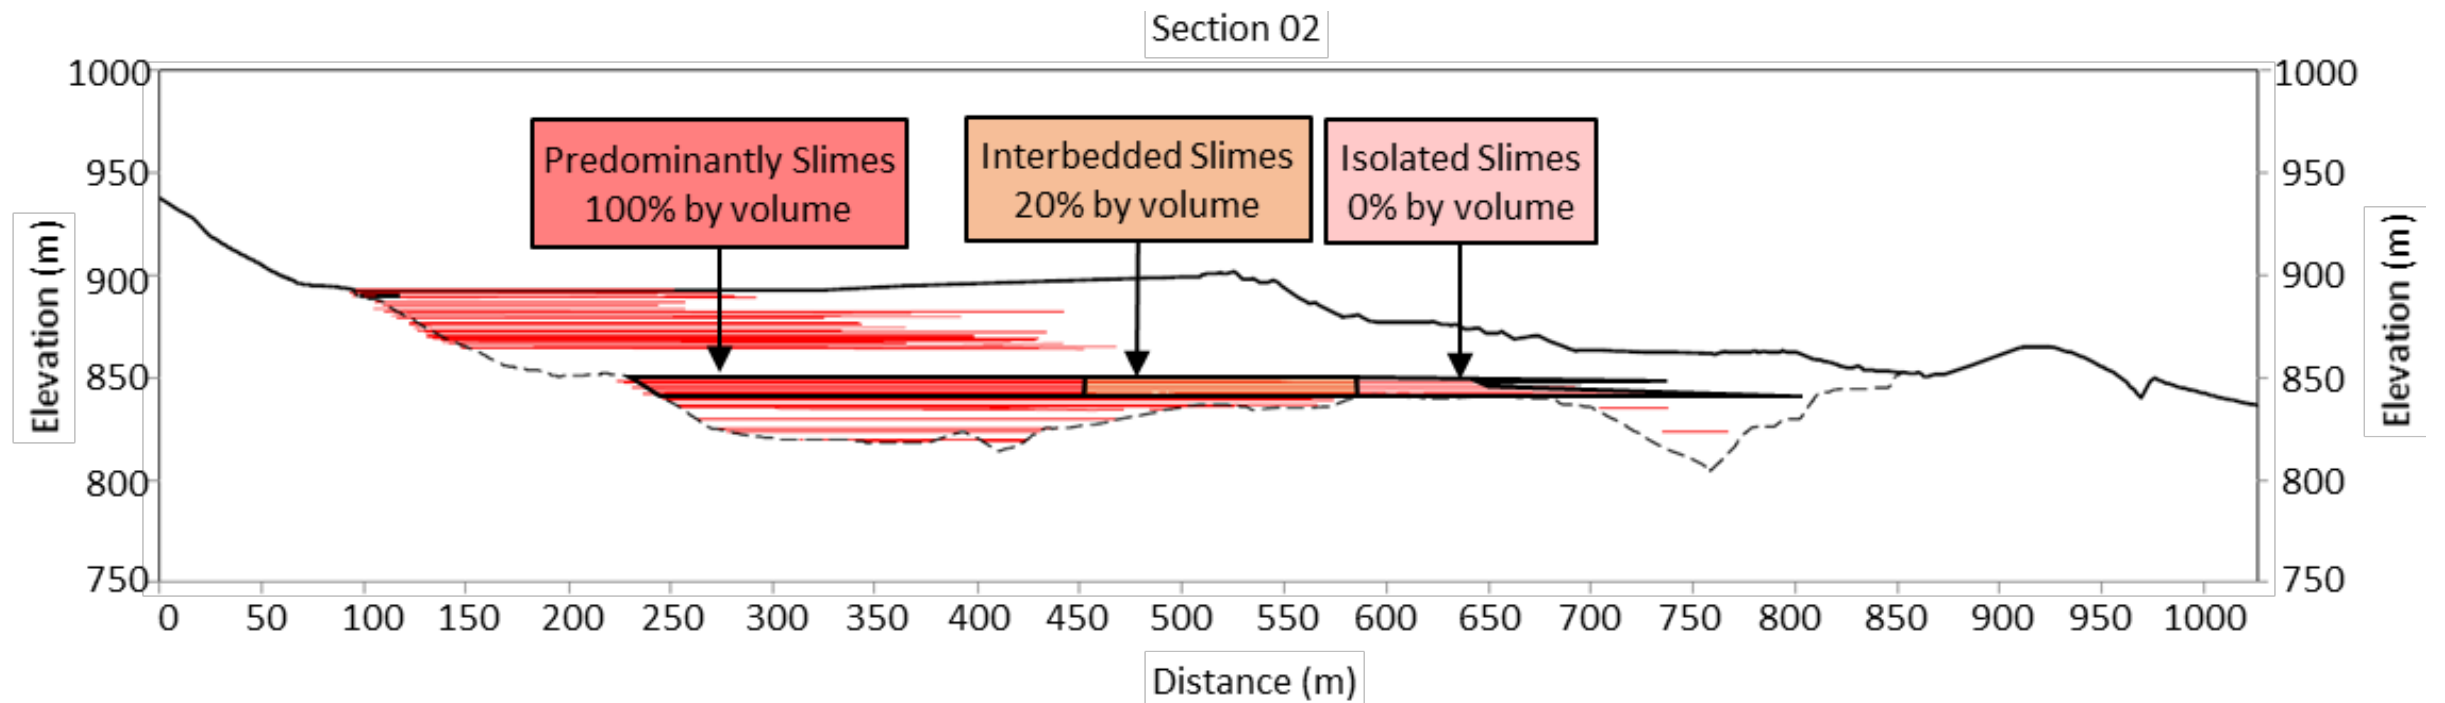
# Section 02 on Left Abutment Setback

All tailings were liquefiable

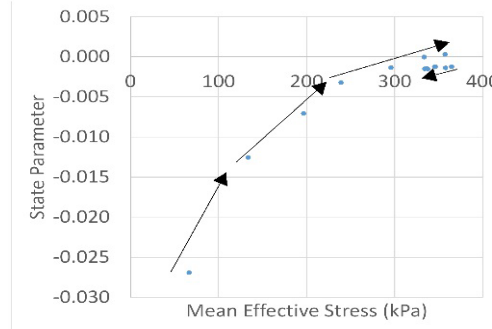
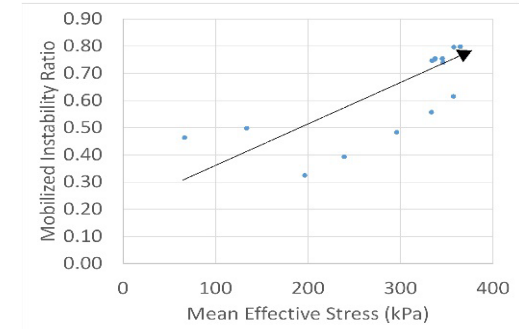
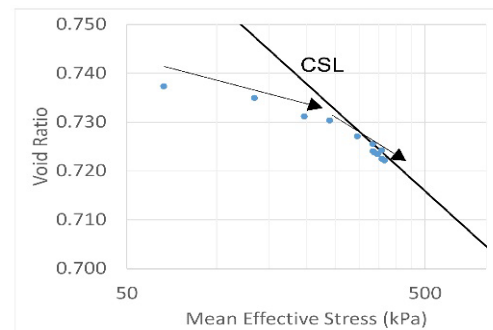
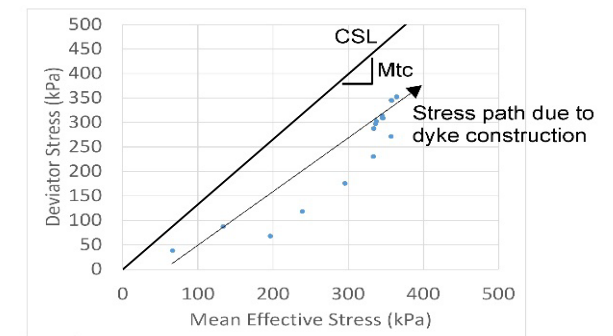
**Response of Sand Tailings at Interface between Sand and Slimes Throughout Dyke Construction**

• Response to Modeled Dyke Construction

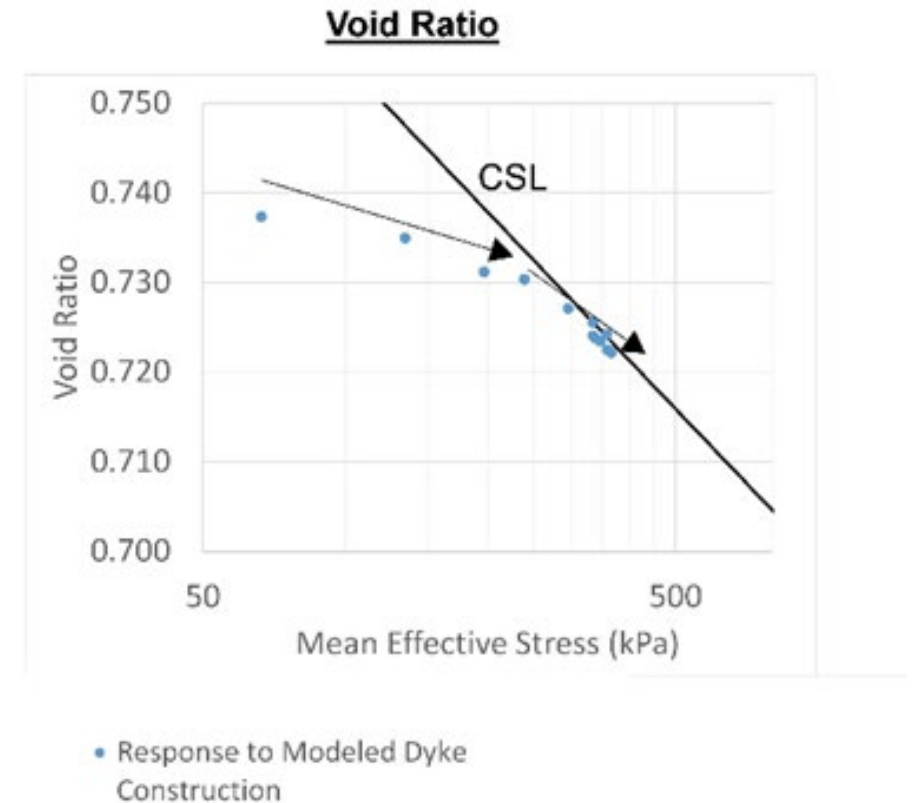
# State is key, not density

- General feeling on design project team was that tailings density was increasing so dam was getting more resistant as it was raised. NOT TRUE
- If the state parameter starts out on the dilatant side of the CSL, raising the dam increases the state parameter; can go from dilatant to contractive
- Much more awareness of the importance of calculating the state parameter from the CPT.
- This originated with Been and Jefferies in the mid-1980s and was streamlined with Plewes et al in the early 1990s.
- Estimates of state parameter still being improved
- Normally plot both state parameter and  $Q_{tn,cs}$
